Petroleum & Gas Inspectorate | Alert | No.105 V 1 | 23 February 2023

Gas cooktop connecting elbow failure

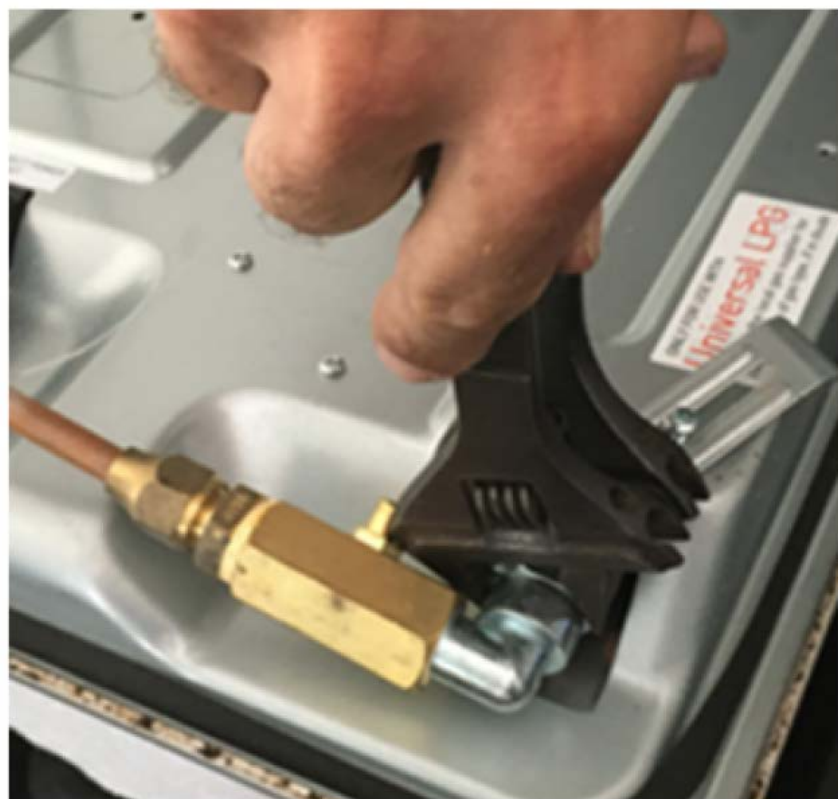
The incidents of failure have occurred in both domestic kitchen installations (see Images 1a and 1b) and recreational vehicle slide out kitchen installations (see Images 2a and 2b).

Image 1a - Domestic kitchen elbow assembly

- **Installers should ensure connecting elbows** are correctly located and orientated and that joints are **not subjected to stress** or strain by overtightening.
- **Installers should ensure that consumer piping is adequately supported** and that connecting elbows are **not subjected to stress** or strain.

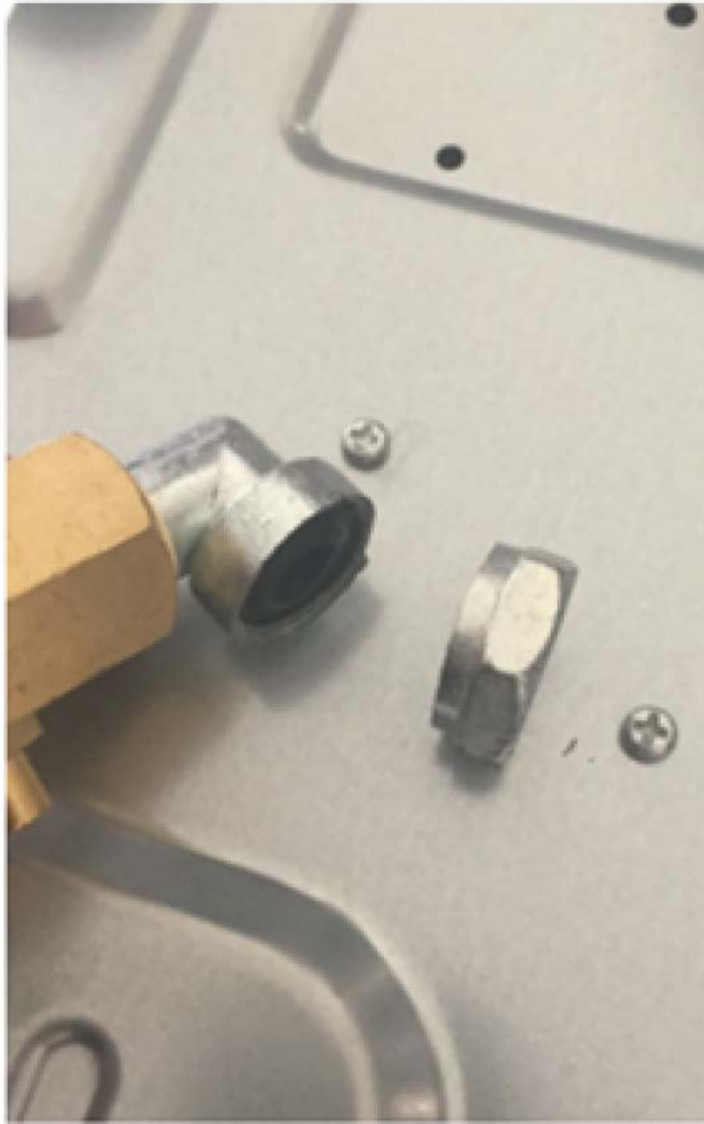
Initial information suggests causal factors include installation practices that result in the connecting elbow being subjected to excessive stress, strain, and accelerated material fatigue, ultimately resulting in failure and the potential of gas leakage.

1. Excessive torsion when making and tightening gas joints, resulting in strain and fatigue being created within the material of the fitting.
2. Not providing adequate support of consumer piping, resulting in strain and vibration being transferred into the fitting.

Image 1b - Domestic kitchen failure

- **Installers** should check connecting elbows of appliances they service or repair for **gas leakage, signs of cracking or fatigue**.

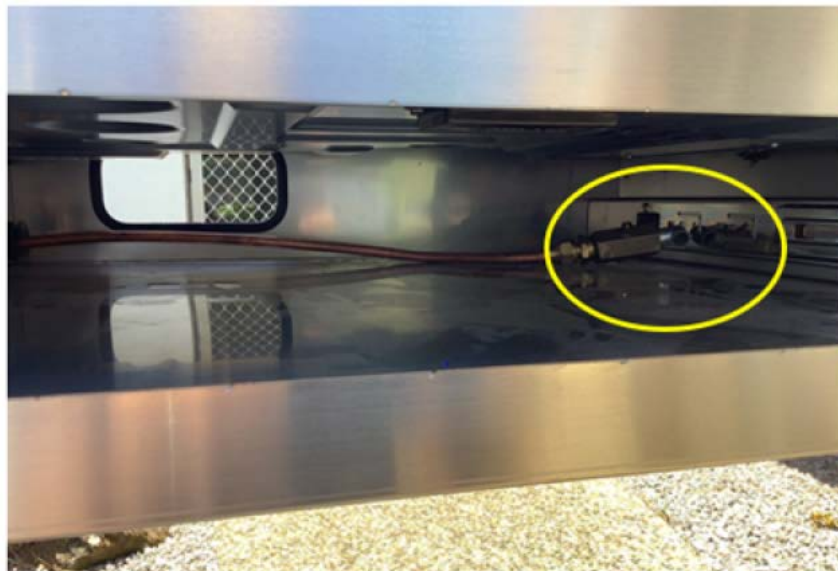
Image 2a - Failed connecting elbow in recreational vehicle

Note: This is critical in recreational vehicle gas systems due to the potential of vibration during travelling.

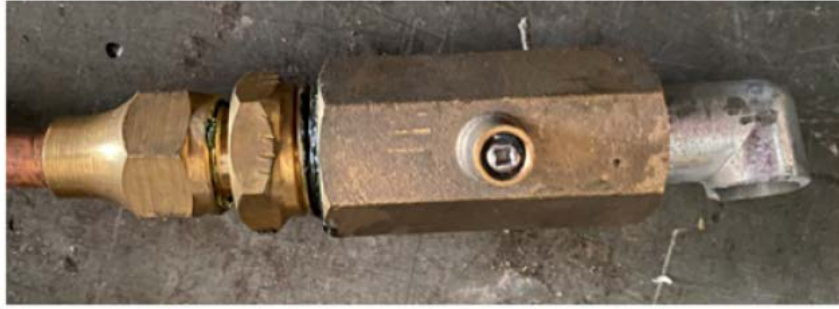
Image 2b – Failed connecting elbow in recreational vehicle
